TREC TECHNICAL REPORT 61-7

**STUDY AND EVALUATION OF PORTABLE AIRCRAFT  
MAINTENANCE HOISTING EQUIPMENT**

FINAL REPORT

Project 9-38-01-000, HT 12.103

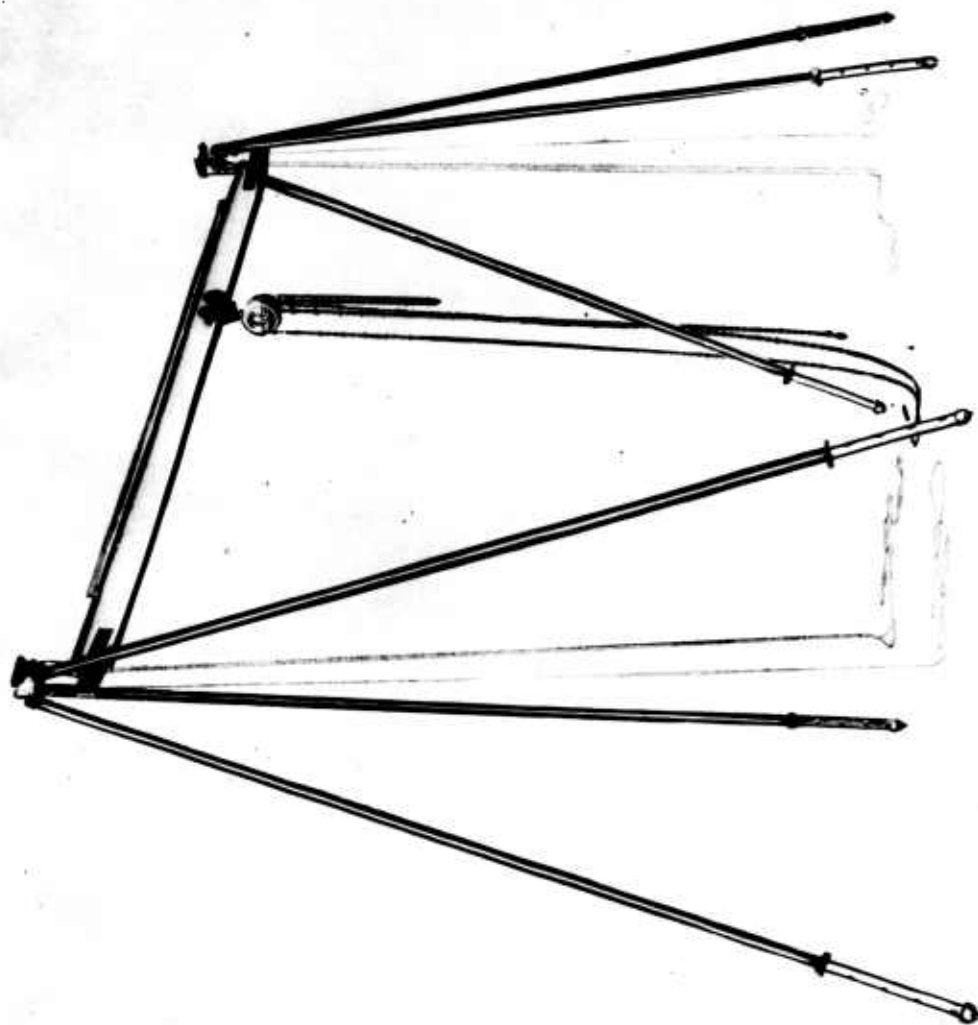
Figure 1. Complete Tripod Gantry Assembly.

The model 2008 tripod gantry portable hoist consists of an aluminum I-beam monorail that is supported at each end by an adjustable tripod, which is constructed essentially of steel (Figure 1).

The arrangement of adjustable-height tripods supporting an aluminum alloy I-beam results in minimum weight because all major components of the tripod end supports contribute directly to the lifting capability of the I-beam. All components are primary members in compressive load; none are in tension; none are secondary load members whose chief function would be to maintain the proper shape of the configuration.

The height of the tripod end supports can vary from 12 to 23 feet. The individual legs, constructed from steel tubing, can be telescoped and adjusted to meet sloping or other restricting conditions of the terrain. A spring-type pin is used to lock each leg at a selected height. Since three points determine a plane, the tripods are perfectly stable and exhibit no "rocking" characteristics of supports. (Each tripod end support can be used independently, with a lifting capacity of 2,000 pounds.)

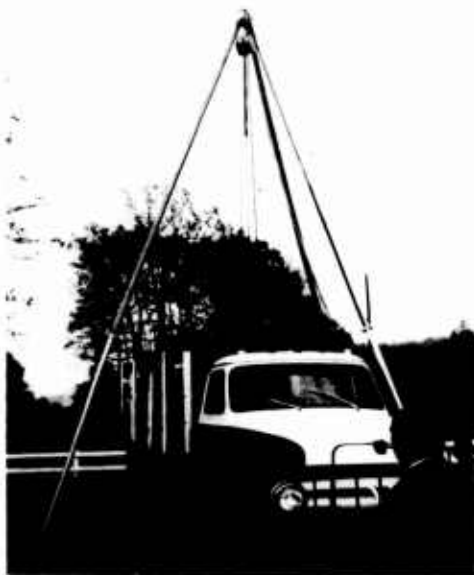
Figure 2. Photo shows the tripod fully extended, with the steel lower portion replaced with an aluminum alloy tube of .120 wall and made of 6061T6 alloy. The load is approximately 3,700 pounds, 4,000 pounds being a full 100-percent overload.

There is considerable bowing in the legs at this loading, indicating that it could not satisfactorily take the required 100-percent overload.

With steel lower tubes, replacing the aluminum alloy of Figure 2, the weight has been increased by 40 pounds per tripod.

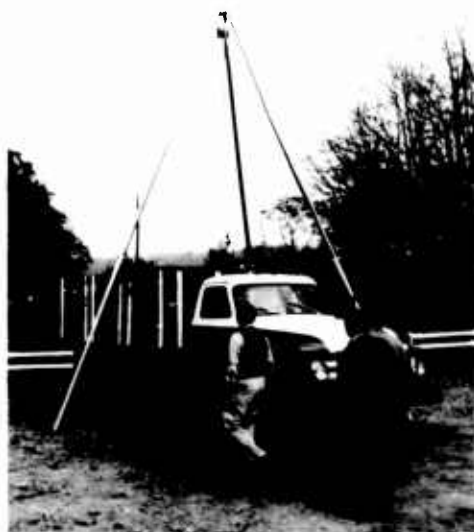
Figure 3. Photo shows the tripod fully extended, using steel on both upper and lower legs. The tubes have almost undetectable bowing at the full 100-percent overload of 4,000 pounds.

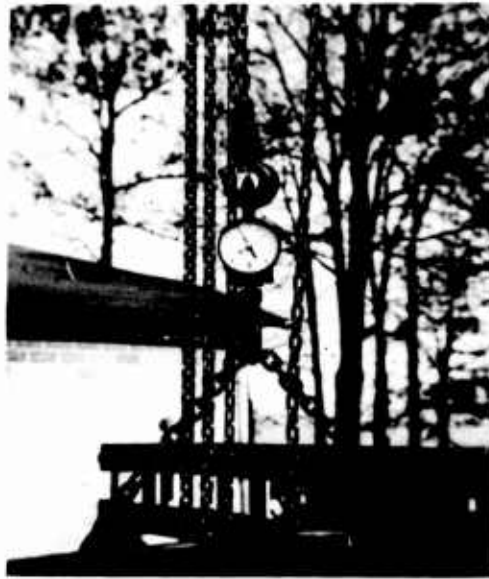
Figure 4. Photo shows a close-up of the gage while the tripod shown in Figure 3 was under test.

The reading is just under 4,000 pounds.

All test loads were measured with a calibrated gage, and the 100-percent overload requirements were met without exceeding the yield point in any instance. Thus, the unit completed the tests without damage of any kind.

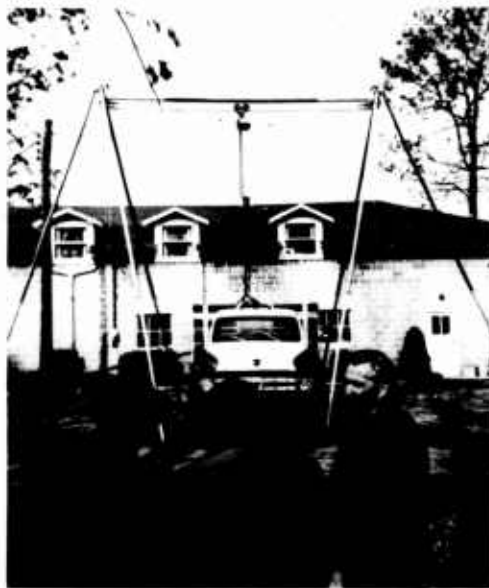
Figure 5. Photo shows the complete tripod gantry in place under a full 100-percent overload of 4,000 pounds.

The load is at the center of the I-beam, with the result that the two tripod end supports are being subjected to only 2,000 pounds each.

This view shows the I-beam cap, which, with the addition of 16 pounds, has increased the I-beam capacity from 2,700 pounds to over 4,000 pounds.

restores a balance of strength between the lower fibers in tension and the upper fibers in compression. The result is maximum use of the I-beam. Thus, with the "cap", the I-beam, which had previously failed at under 2,800 pounds, was able to support a load of 4,100 pounds, at which load, sag of the I-beam at the center point was 1-1/2 inches, though the yield point had not yet been reached. Displacement of the I-beam was proportional to the load; thus, sag at the rated capacity of 2,000 pounds was 3/4 inch, an acceptable figure.

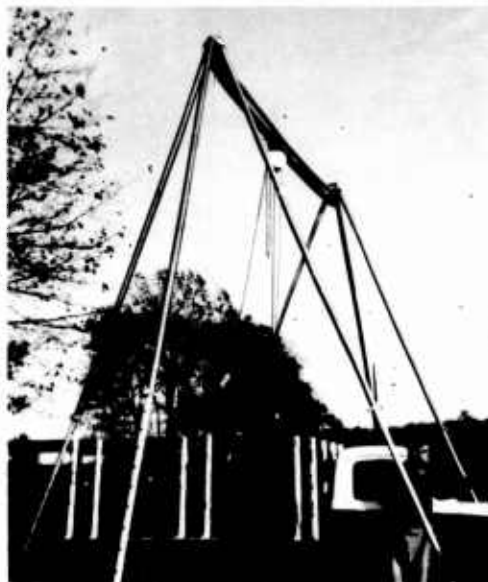
Figure 6. Photo shows the tripod gantry without the cap on the I-beam.

Though being subjected to a load of only 2,700 pounds, the I-beam is sagging badly and is also being distorted laterally along its longitudinal axis and will, with the addition of about 100 pounds, "roll over" in such a way as to unload the compressive load from the upper portion of the I-beam. The cap prevents the I-beam from unloading by lateral distortion.

Tests were made of the I-beam capacity at the center-span location, the critical point. Without a "cap", the standard 8-inch-deep 6061T6 aluminum alloy I-beam rotated on its longitudinal axis with less than a 2,800-pound load. With a 10-foot length of standard 4-inch-deep aluminum alloy (6061T6) channel bolted to the top of the I-beam, there was no evidence of rotation and resultant I-beam unloading. The basic theory behind this is, of course, based on the fact that on a relatively long I-beam, loaded at the center, the upper portion of the I-beam is in compression and relatively unstable, compared to the lower portion which is relatively stable, being loaded in tension. At a critical load condition, the upper portion of the I-beam yields in compression, sidewise displacement takes place, and the I-beam rotates to be further relieved of the load. All this can take place before the individual fibers of the I-beam exceed their yield points. The "cap", by greatly stiffening the upper compressive portion of the I-beam,

Only one significant problem was encountered during the design and development of the model 2008 tripod gantry. During the preliminary erection and load tests, the I-beam monorail rotated along its longitudinal axis when a load of 2,700 pounds was applied to the chain hoist. The difficulty resulted from a requirement for a 15-foot monorail span. The contractor successfully solved the problem by bolting a 10-foot length of standard 4-inch-deep aluminum alloy channel to the top of the monorail. This "cap" stiffened the upper compressive portion of the I-beam, restoring a balance of strength between the lower fibers in tension and the upper fibers in compression, which resulted in maximum use of the I-beam.

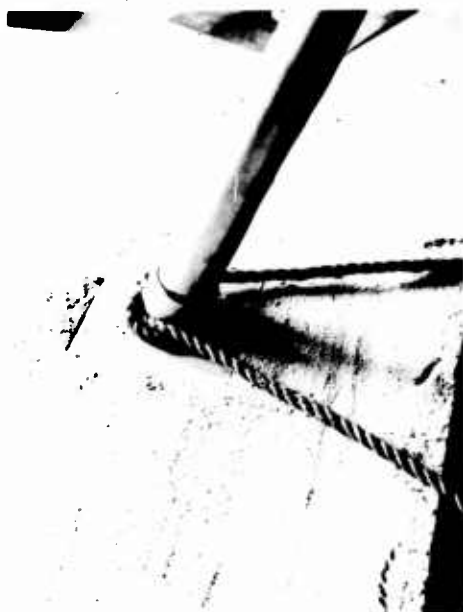
Figure 7. Photo shows the 7-inch square steel plate resting in dry sand and being subjected to 1/3 of the total tripod load of 500 pounds.

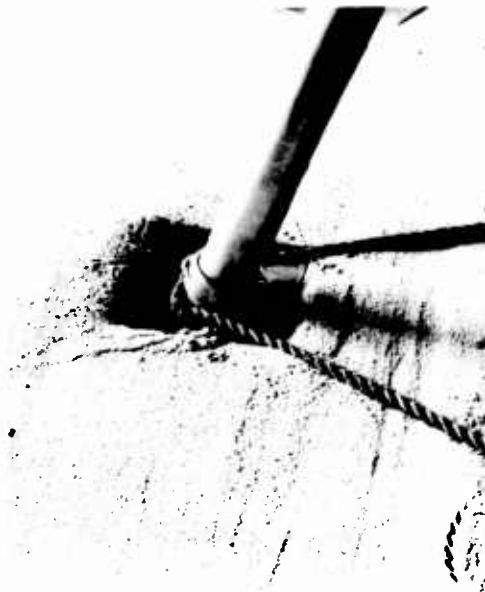
Figure 8. Photo shows the 7-inch square steel plate resting in dry sand and being subjected to  $\frac{1}{3}$  of a total tripod load of 1,000 pounds.

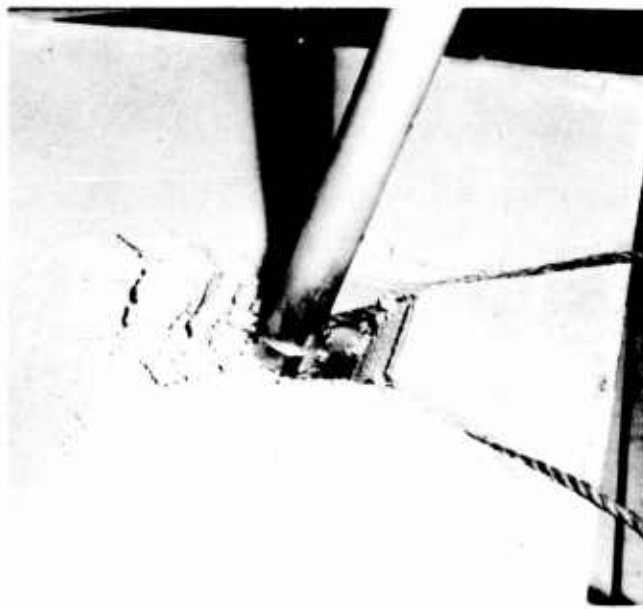
Figure 9. Photo shows 7-inch square steel plate resting in dry sand and being subjected to  $\frac{1}{3}$  of a total tripod load of 2,000 pounds.

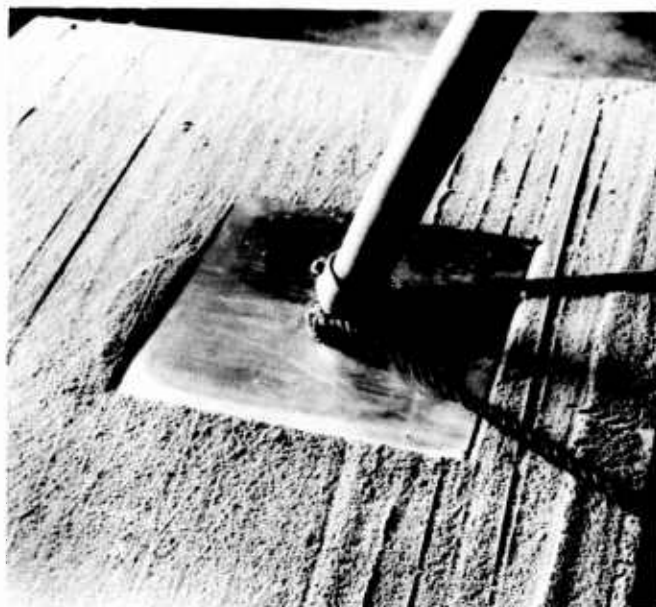
Figure 10. Photo shows 15-inch square steel plate resting in dry sand and being subjected to  $1/3$  of a total tripod load of 1,000 pounds.

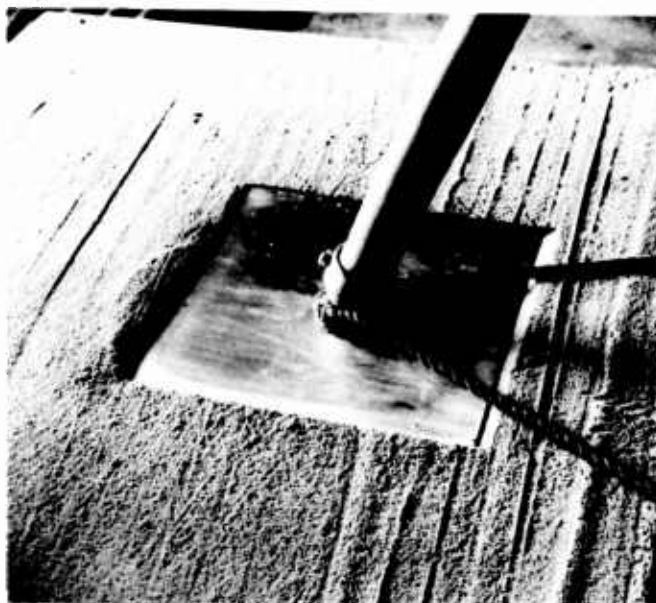
Figure 11. Photo shows 15-inch square steel plate resting in dry sand and being subjected to  $1/3$  of a total tripod load of 2,000 pounds.

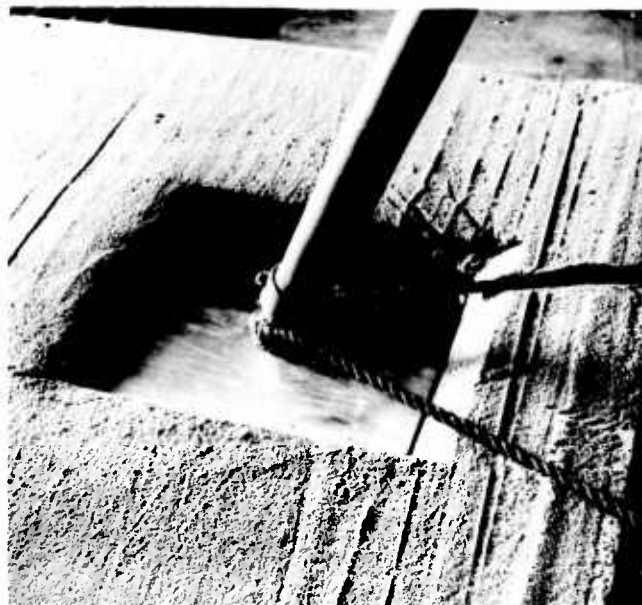
Figure 12. Photo shows 15-inch square steel plate resting in dry sand and being subjected to 1/3 of a total tripod load of 4,000 pounds.
